# Front Drive Axle

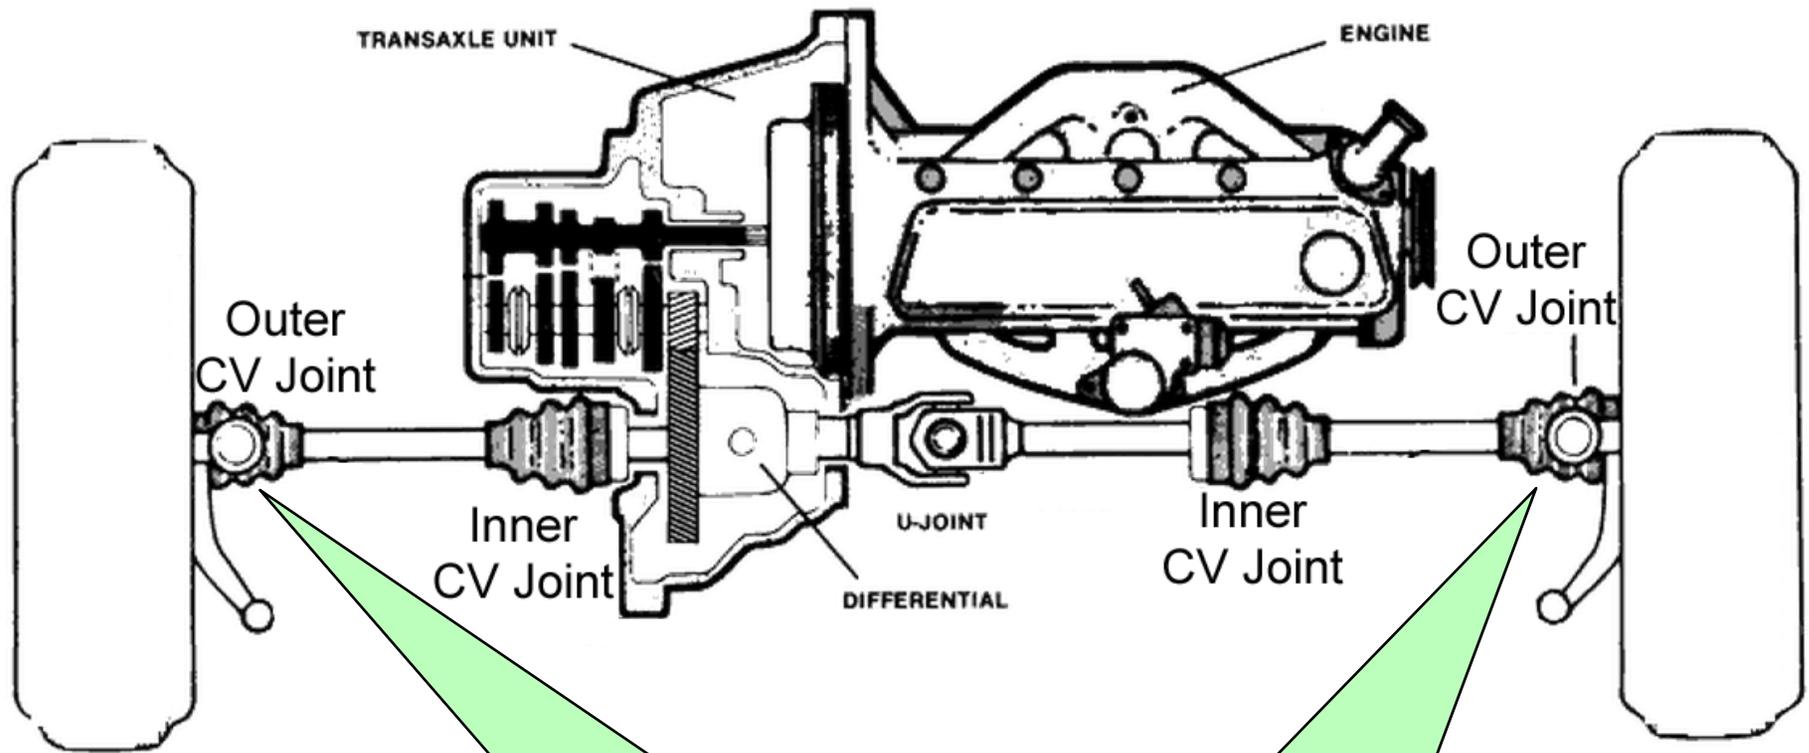
Outer Joints must operate at extreme steering angles

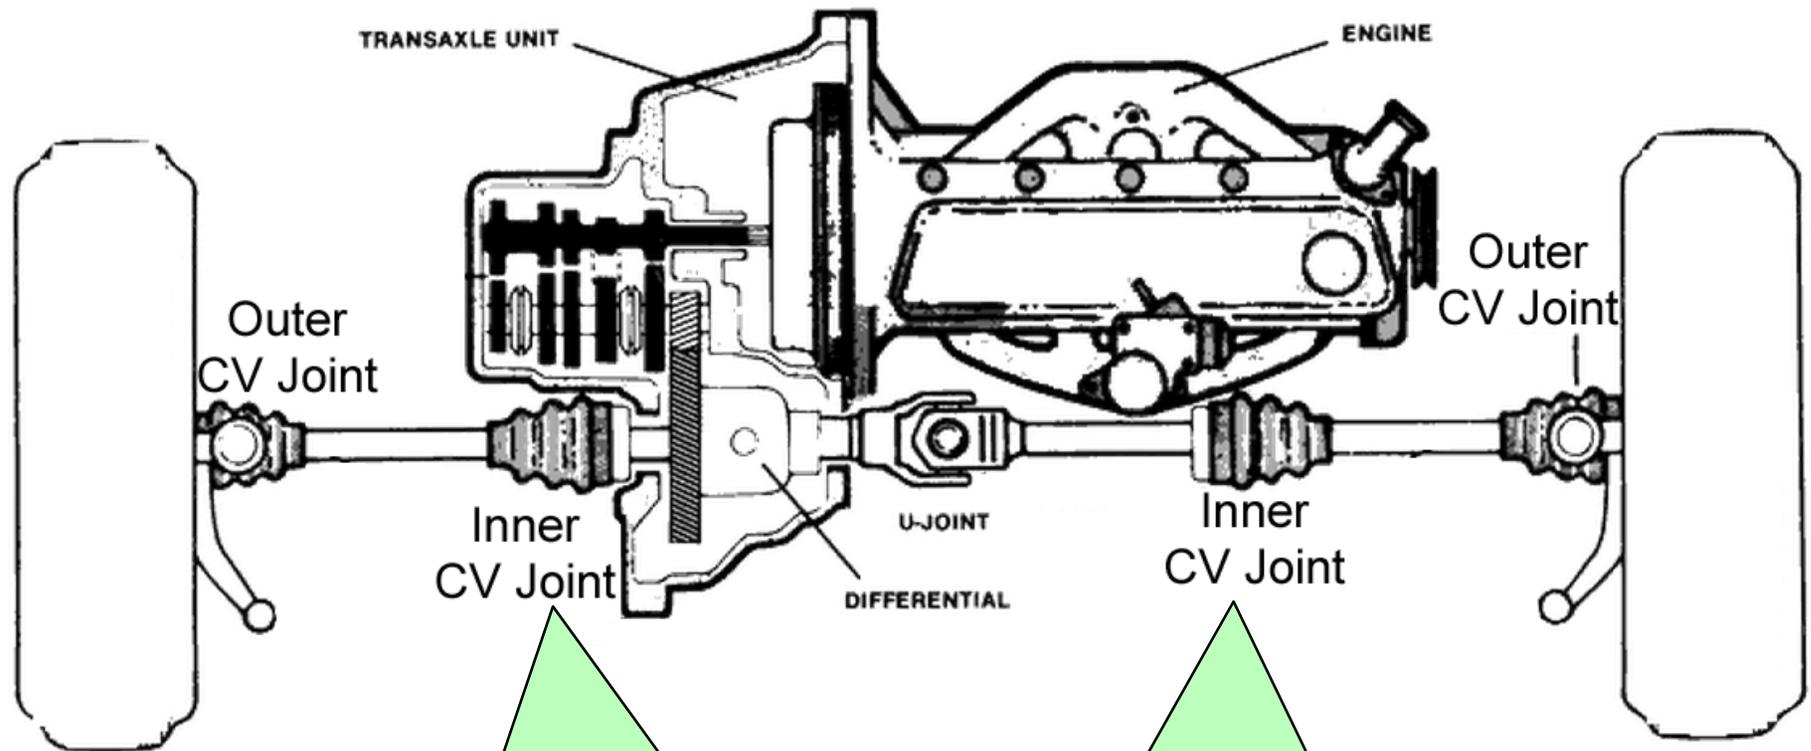
Inner Joints “plunge” to change length on Jounce & Rebound

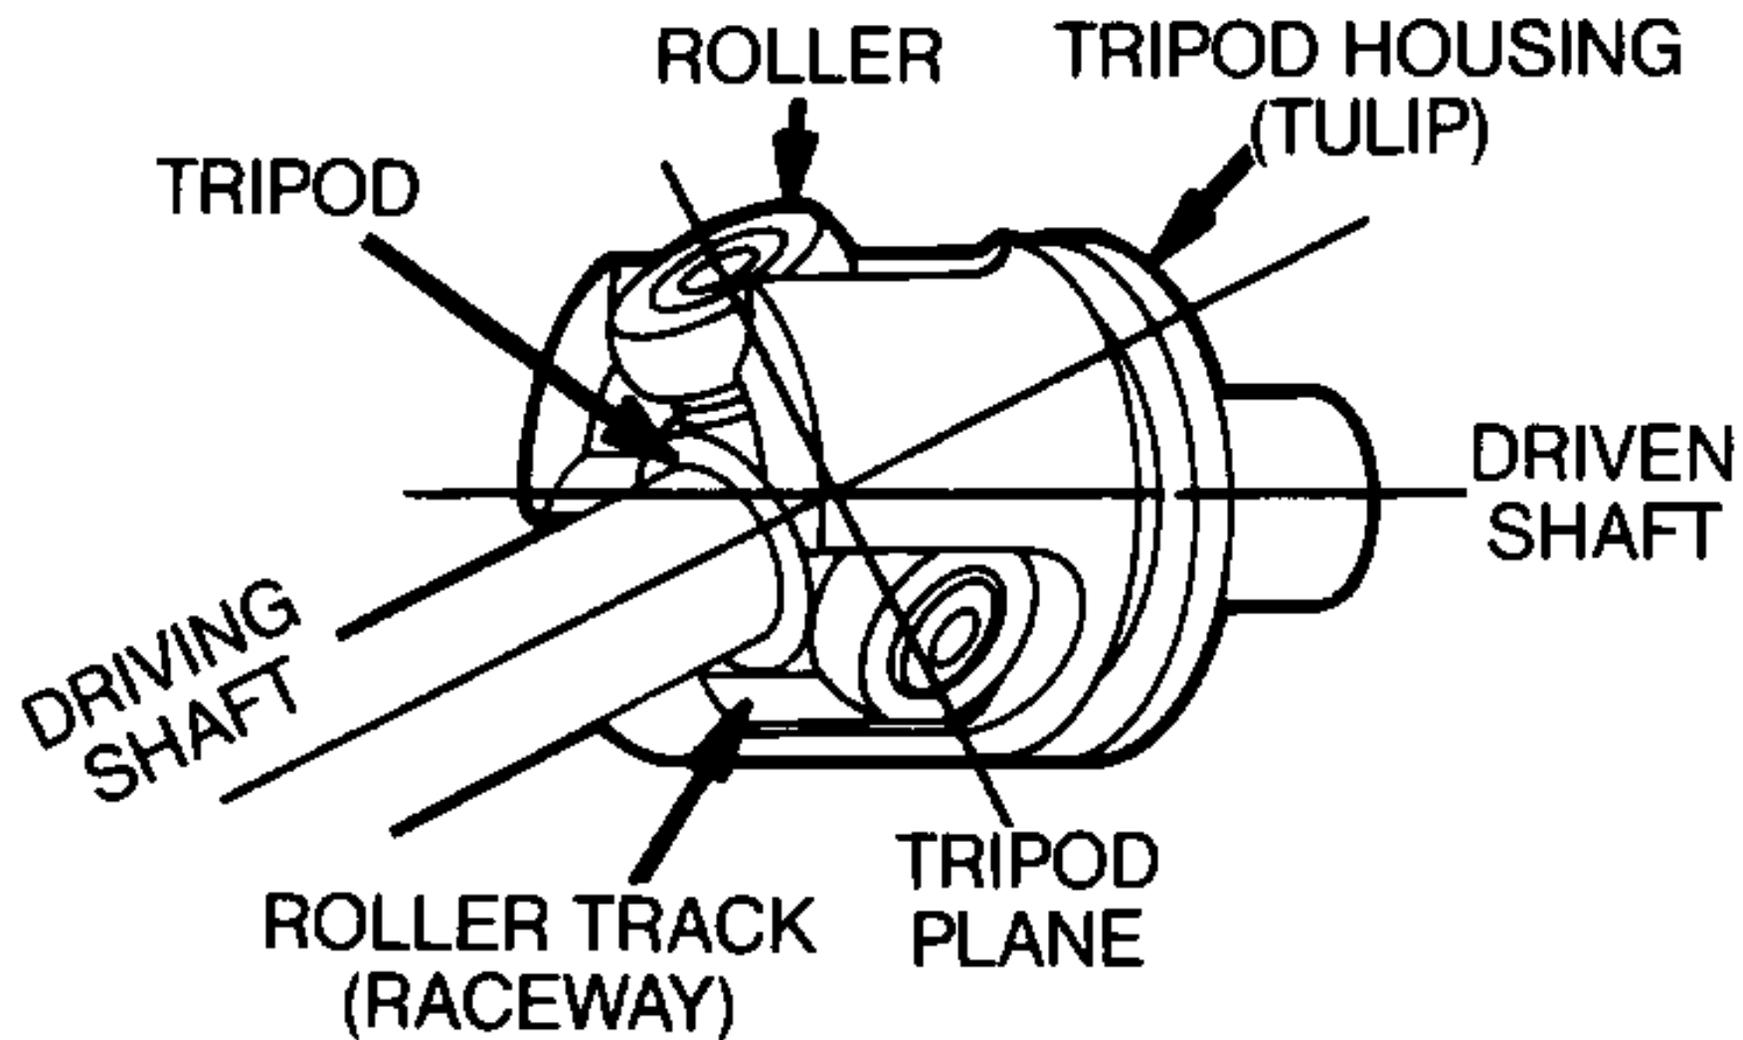
# Tripod joint operation.

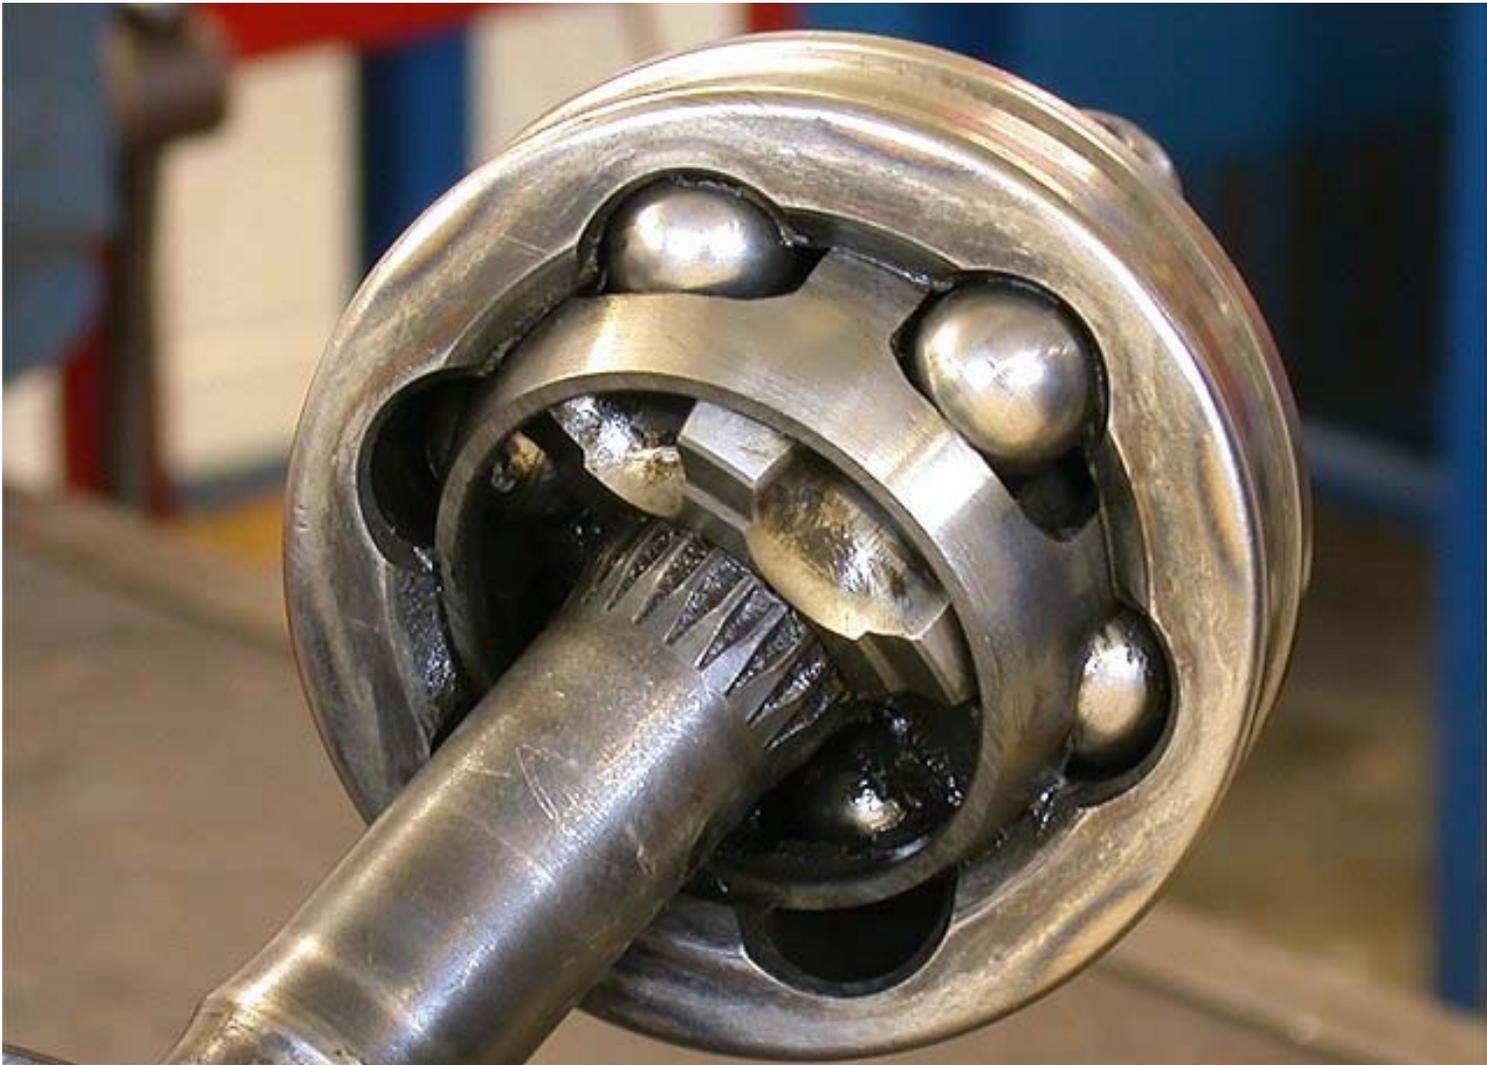
# Rzeppa CV-Joint

Most common type of Fixed outboard CV-joint

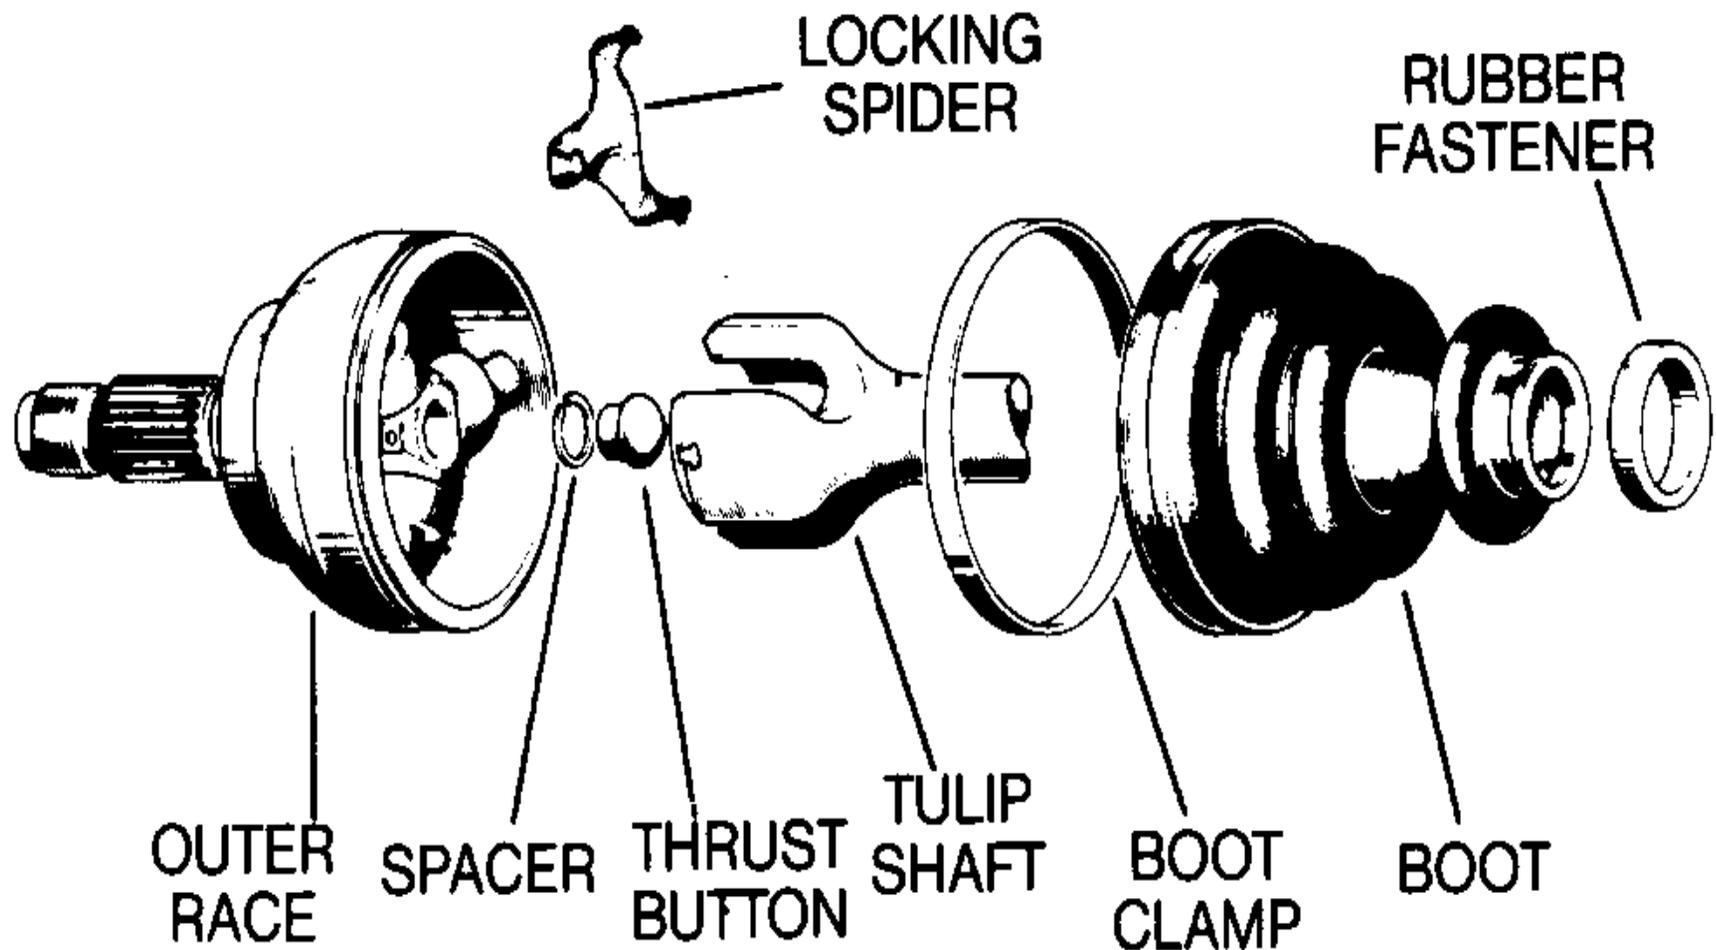
# Outer tripod fixed CV joint.

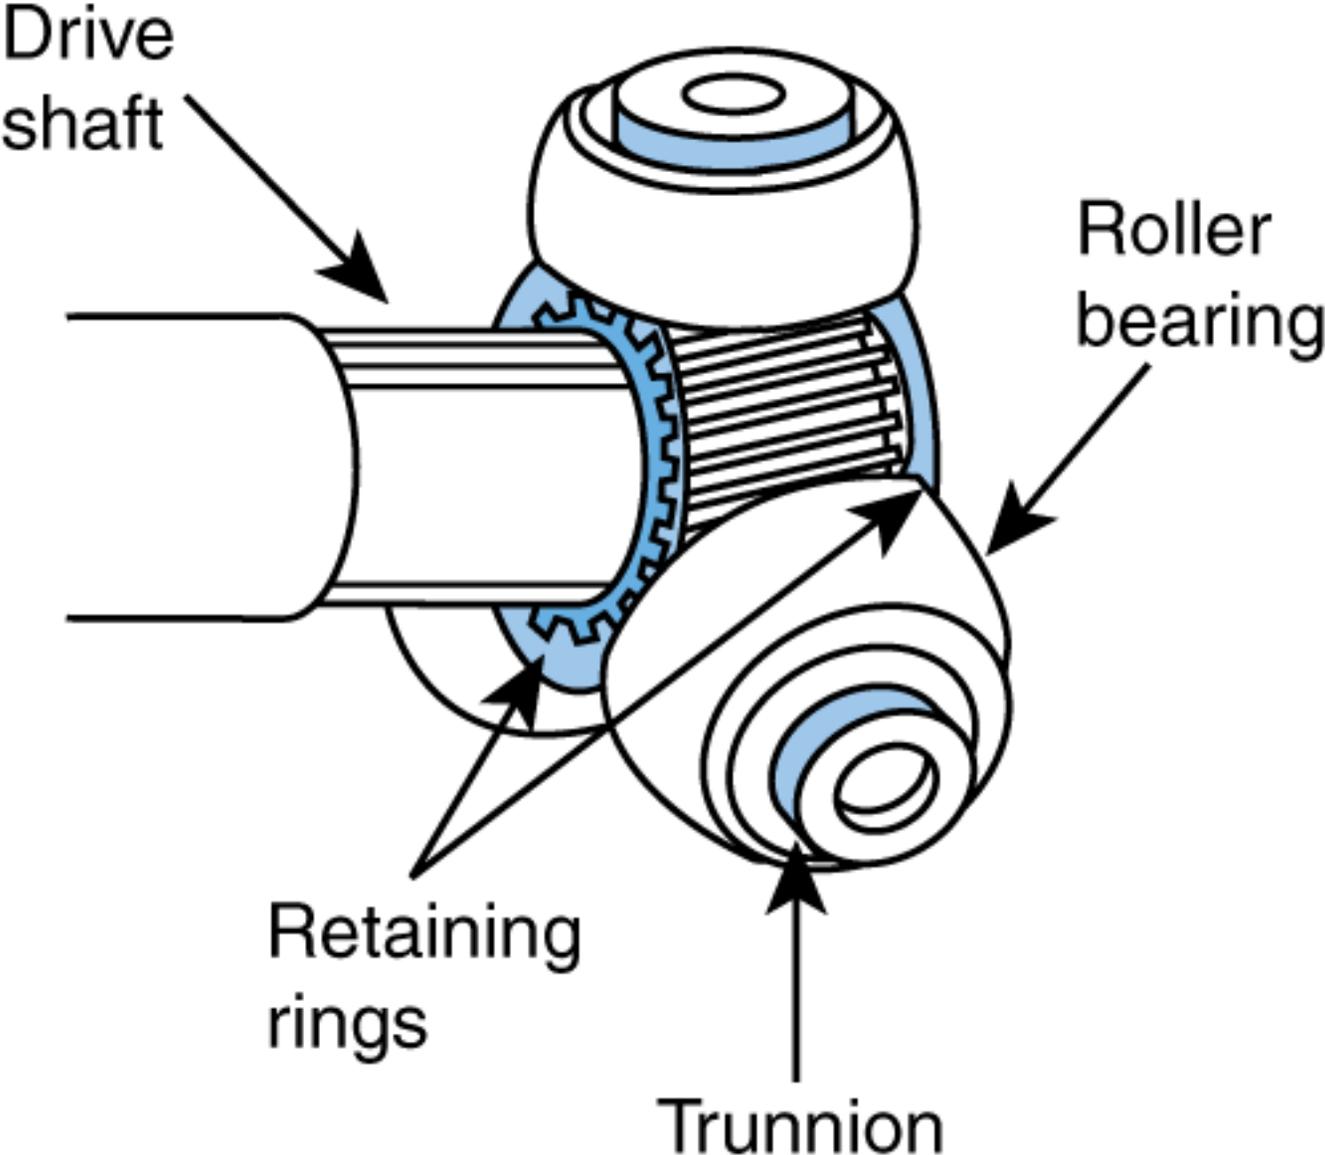
# Tri-pod assembly

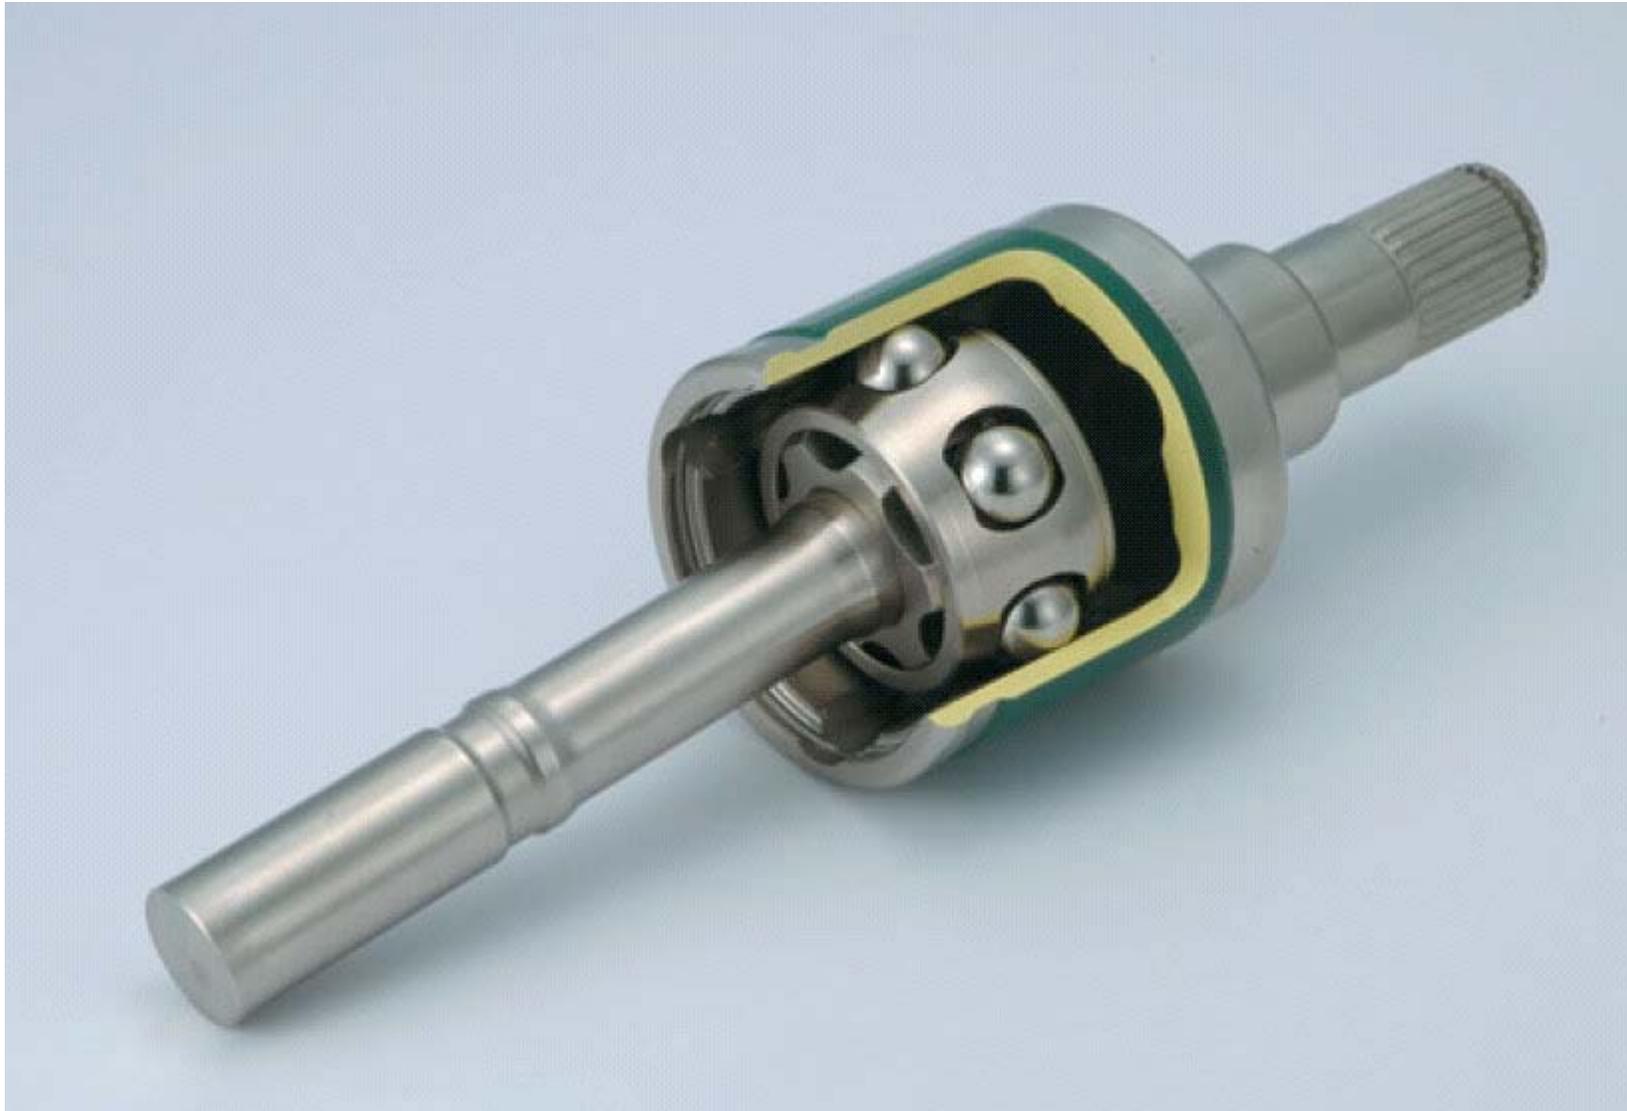
# Double Offset CV-Joint

## Plunging Inboard CV-joint

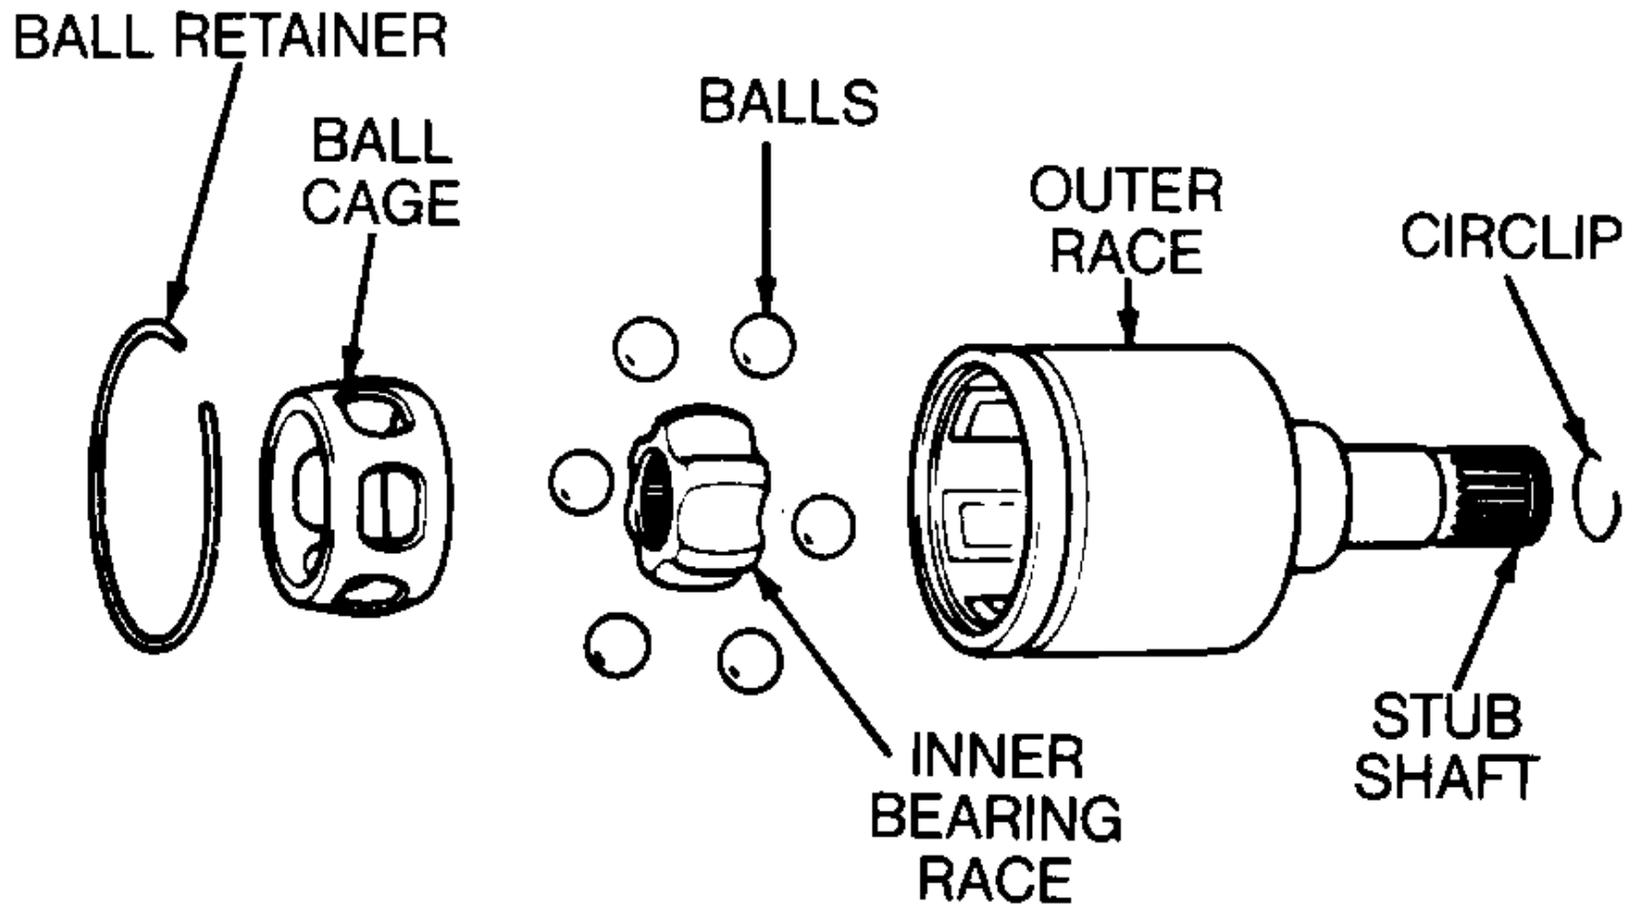
Double-Offset CV joint.

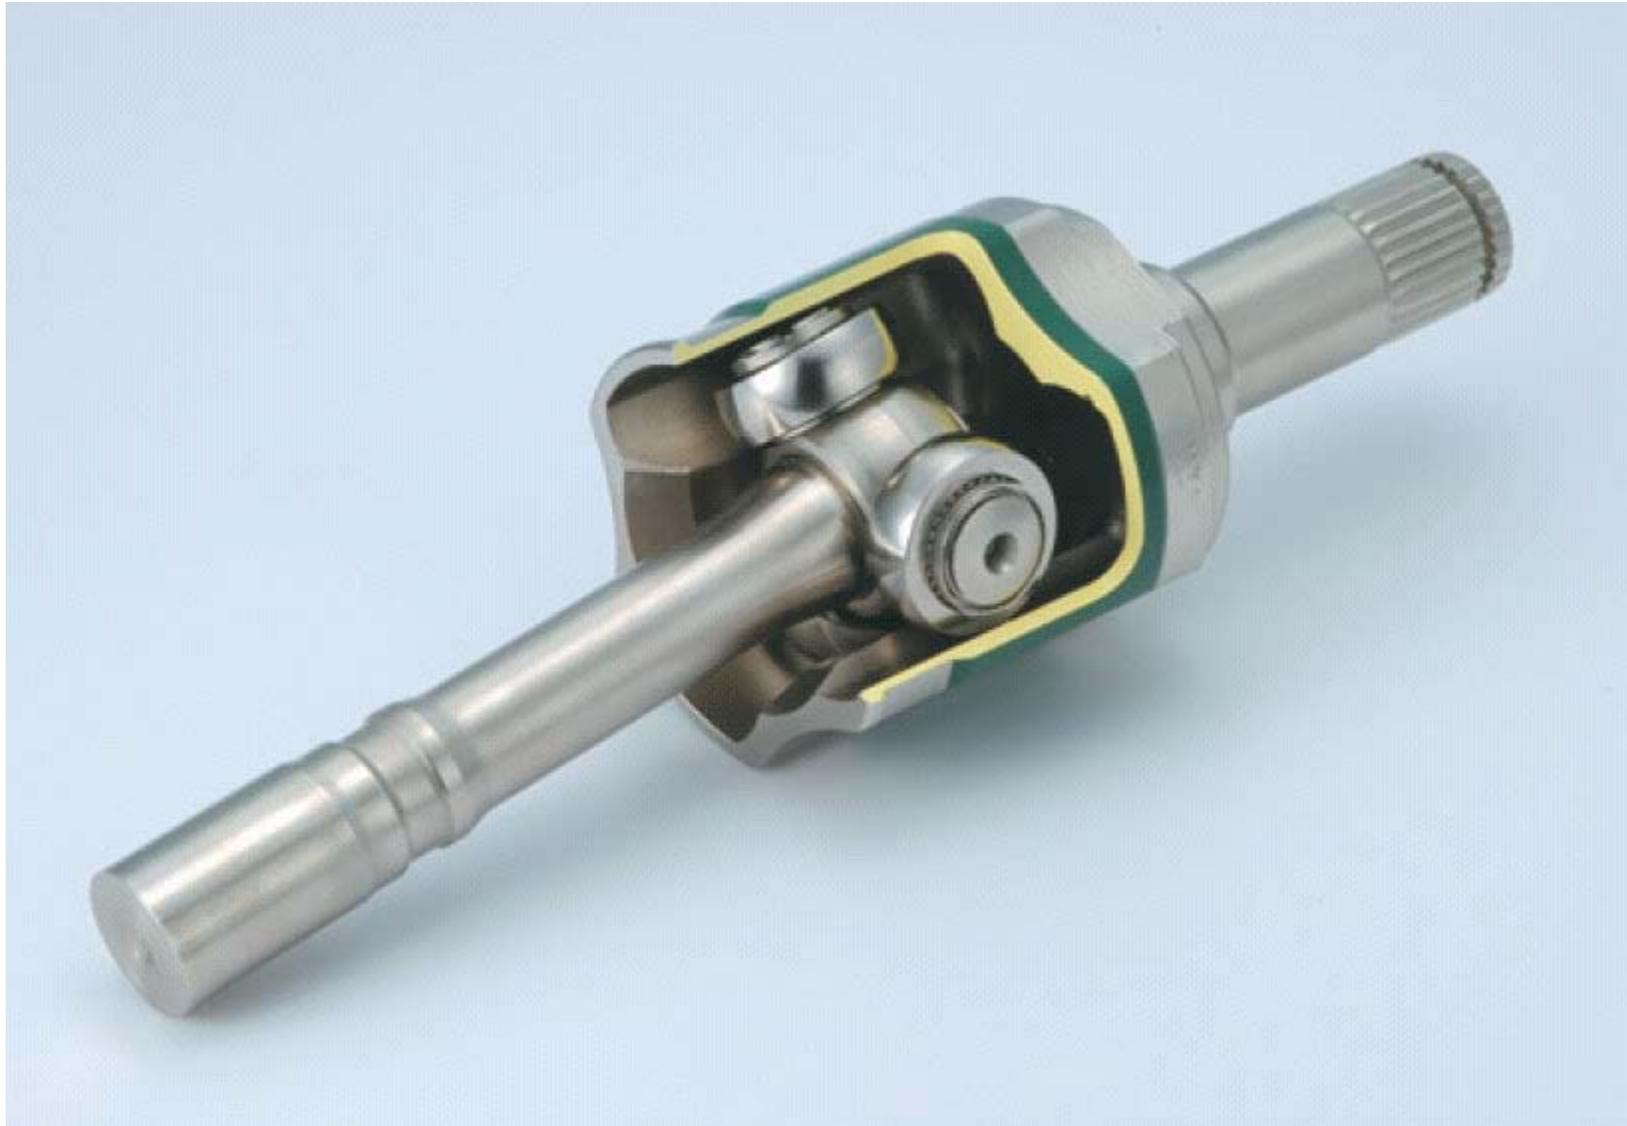
# Tripod CV-Joint

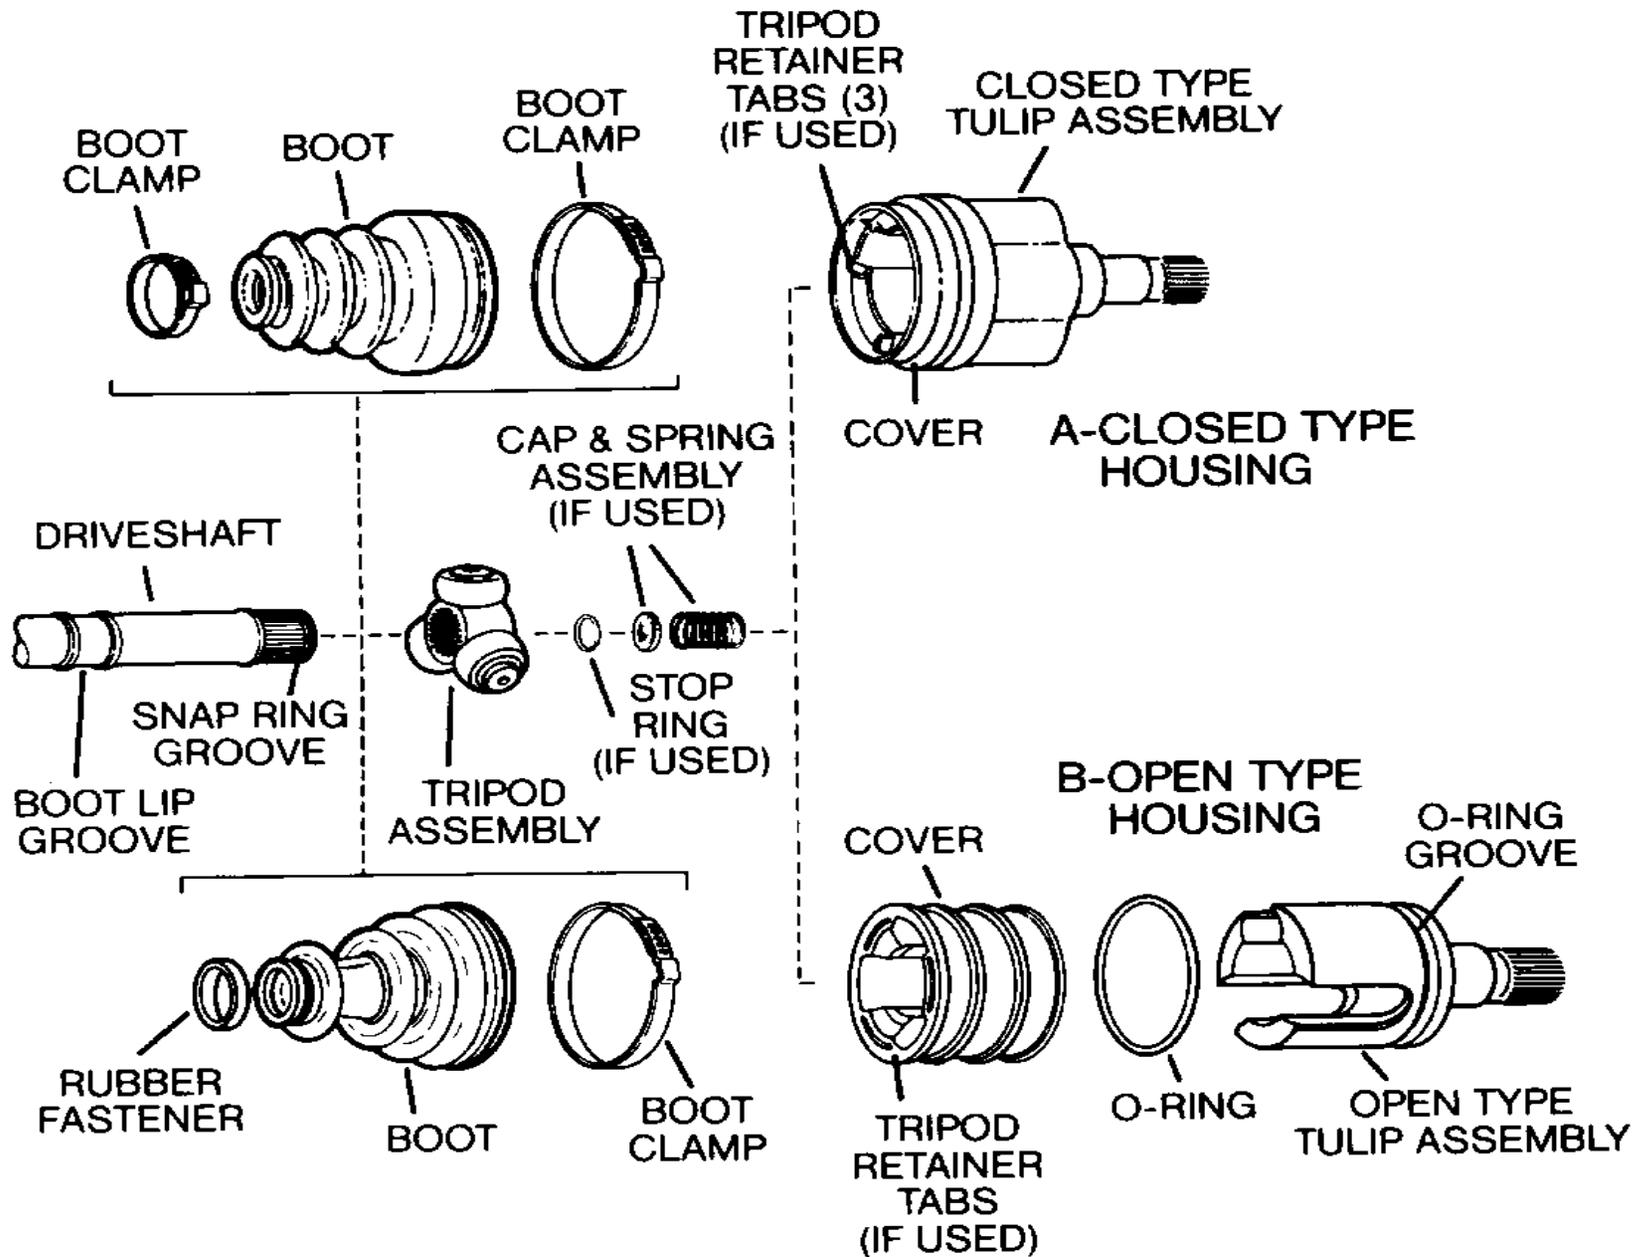
# Inner tripod plunge CV joint.

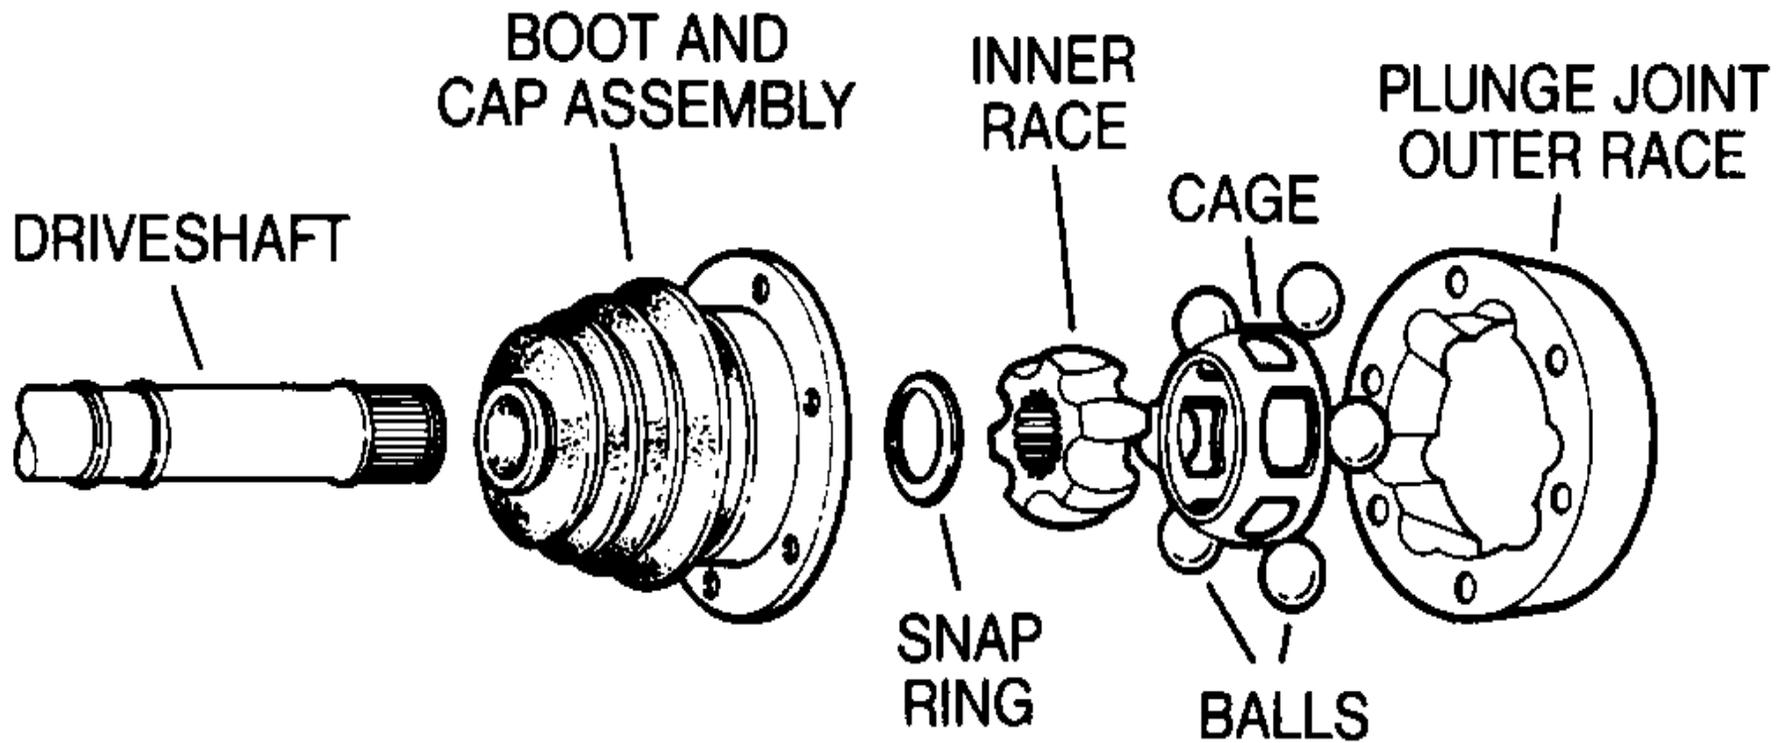
Each ball must stay in original position  
for cage AND inner race AND outer race

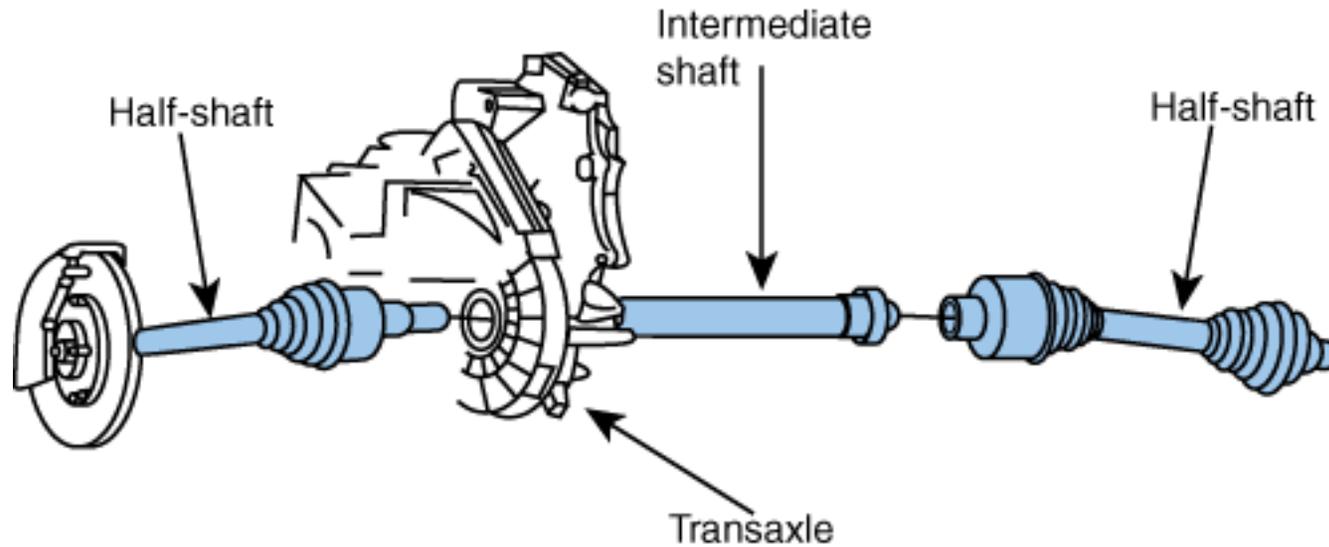
Torque steer is created when halfshaft operating angles are unequal.

The shaft with the least operating angle will require less effort to turn leading to quicker acceleration and torque steer

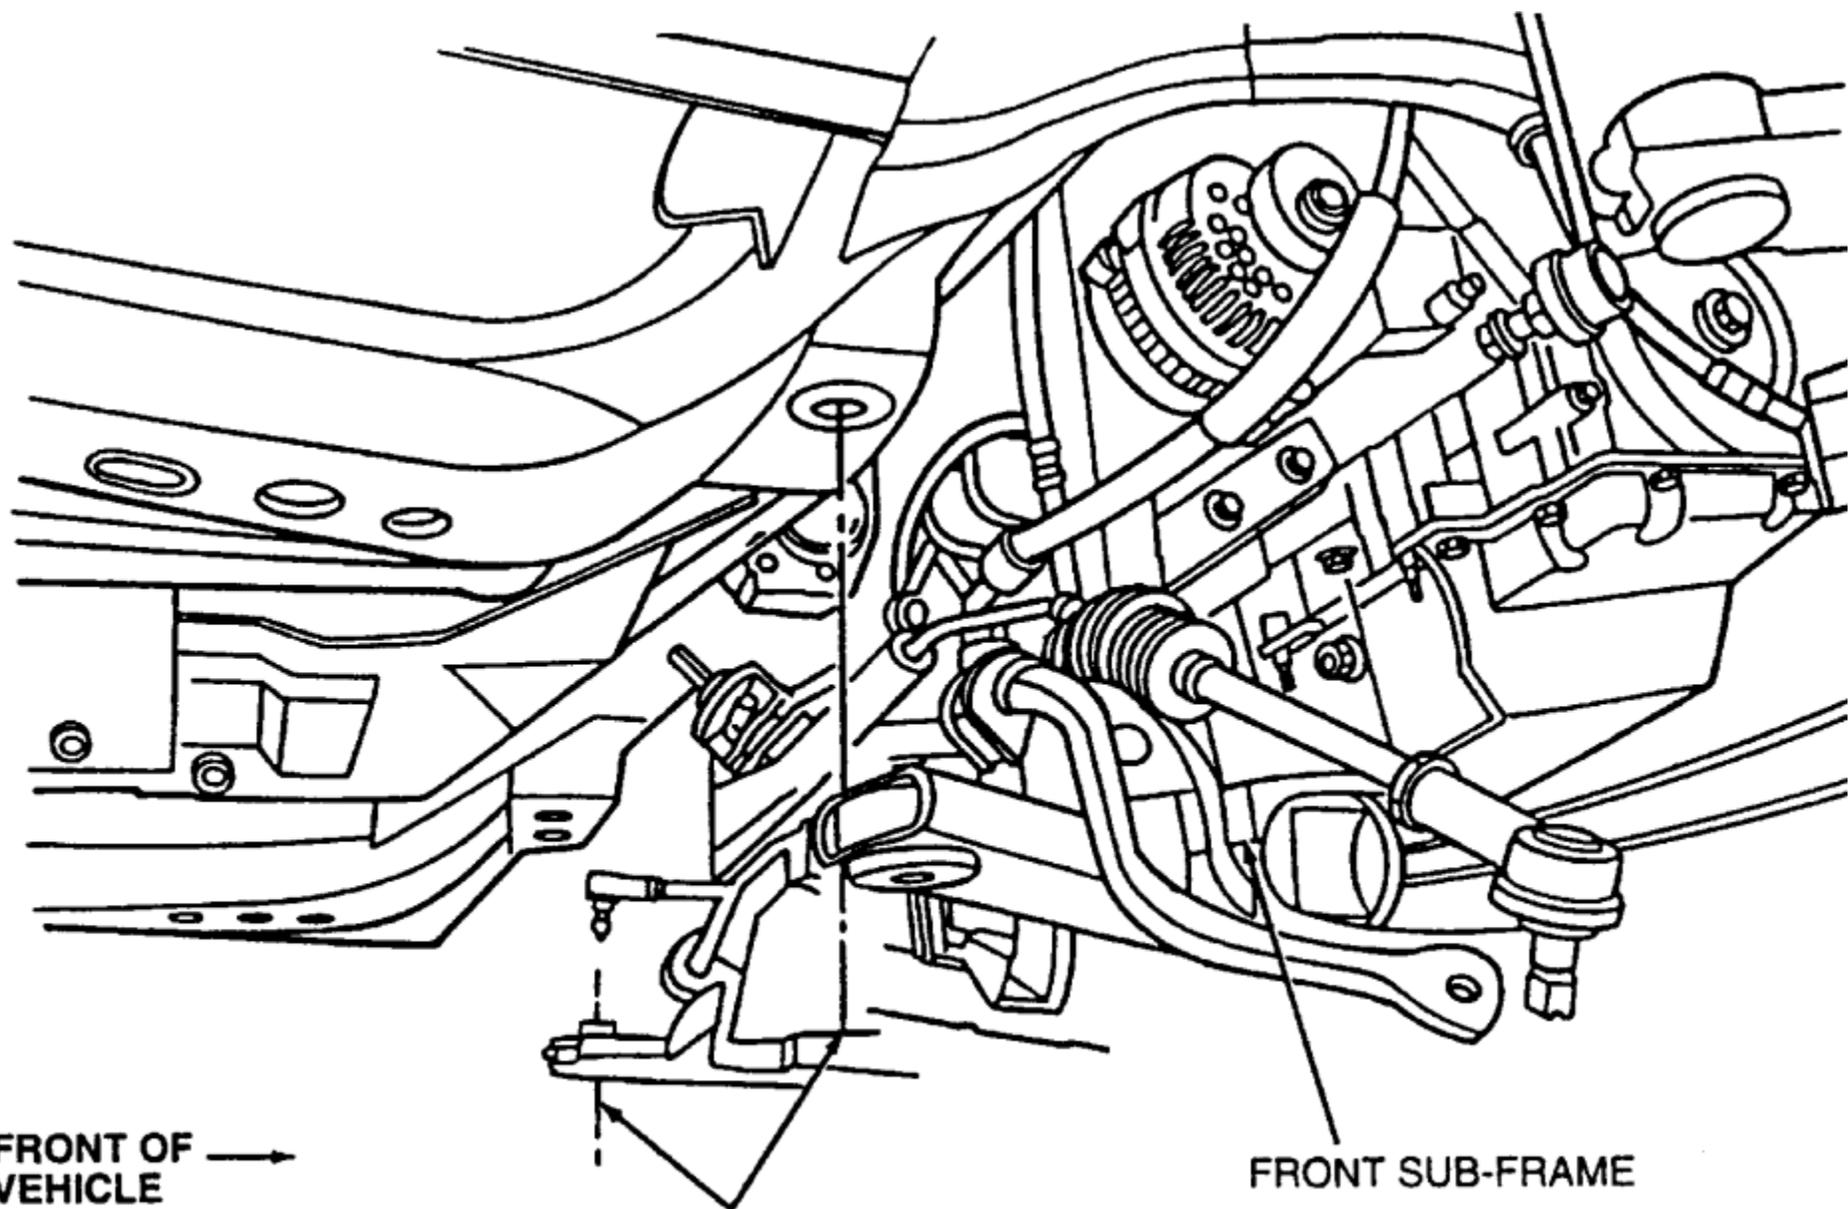
— FRONT OF VEHICLE →

SUB-FRAME  
ALIGNMENT  
HOLES

FRONT SUB-FRAME

FRONT SUB-FRAME RH  
FRONT RETAINING BOLT

FRONT SUB-FRAME LH  
FRONT RETAINING BOLT

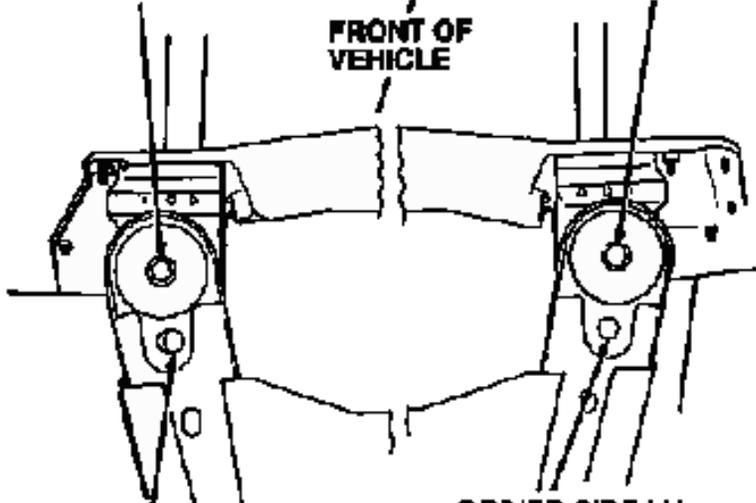
PASSENGER SIDE RH  
FRONT SUB-FRAME TO  
BODY ALIGNMENT HOLES  
(FRONT ONLY) FORE/AFT  
ALIGNMENT ONLY

DRIVER SIDE LH  
FRONT SUB-FRAME  
TO BODY ALIGNMENT  
HOLES (FRONT ONLY)  
FORE/AFT AND  
SIDE-TO-SIDE ALIGNMENT
